Vulnerability Mapping Report

Climate Resilient Road Standards (CRRS) Project Phase 2

For: Department of Environment (Australia)

February, 2015

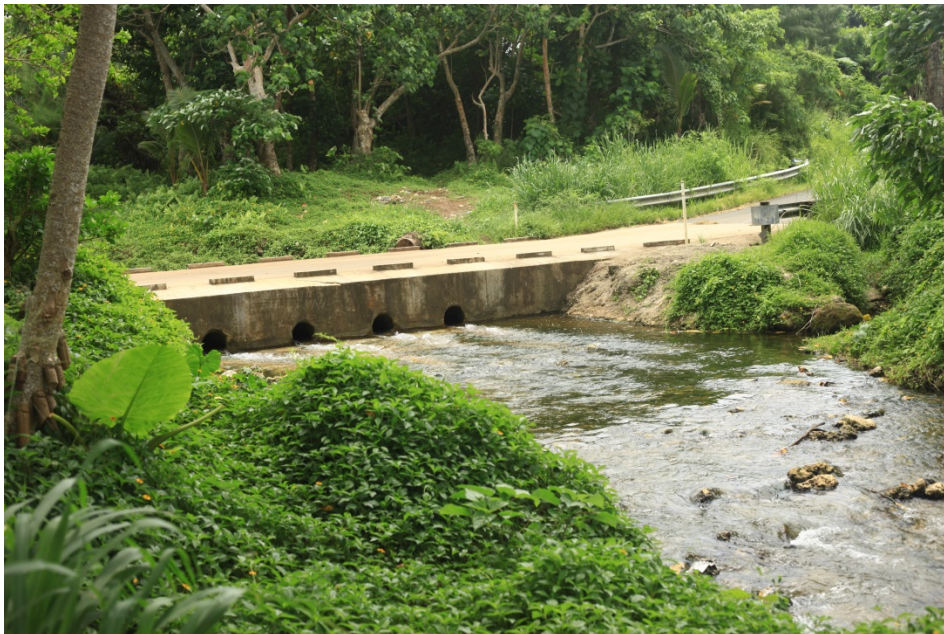
Figure 21 Side view showing vented drift

This is a vented drift. Note the difference in height between upstream (right hand side) and downstream (left hand side) flows. The vents are impeding the flows.

The figures above show two shots of another bridge on the Ring Road. The bridge has vents as the stream is perpetually flowing. The sea is short distance (200m) downstream so this is the exit point of a large catchment. The culverts are of small diameter and are not capable of dealing with heavy flows. There is evidence of overtopping of the road, as scouring is occurring on the road embankment as shown in the figure above.

The concrete blocks are installed to stop vehicles driving off the bridge if attempting to cross when the pavement is under water. Guide posts showing flood heights are provided but no indication is given as to what is a safe height to cross. Warning signs should be provided.

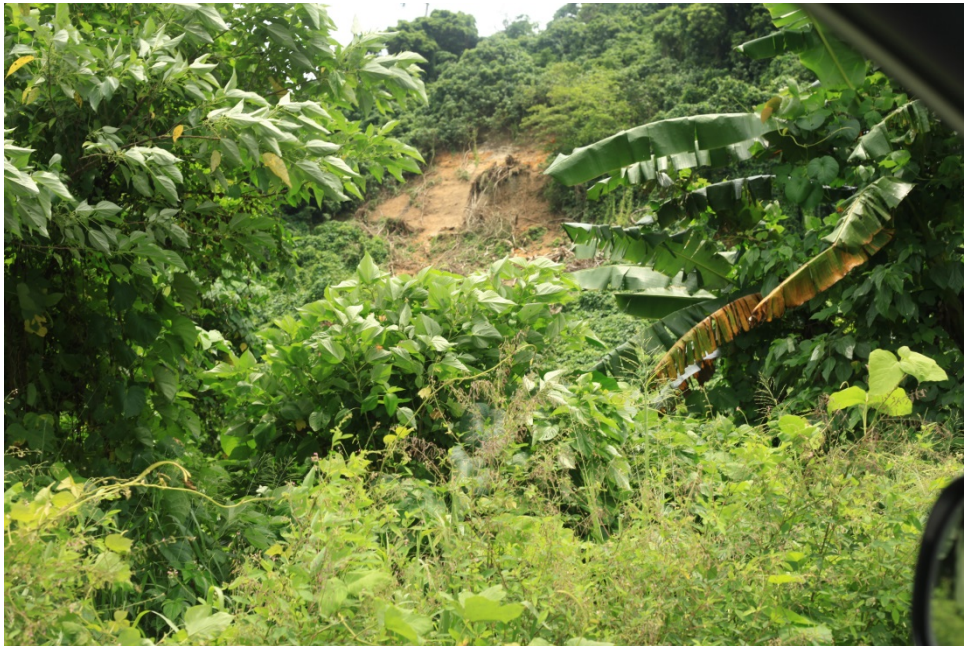
Figure 22 Slope instability above Ring Road

This slope above the road has been deforested and is in danger of collapse. Heavy rains will exacerbate this situation.

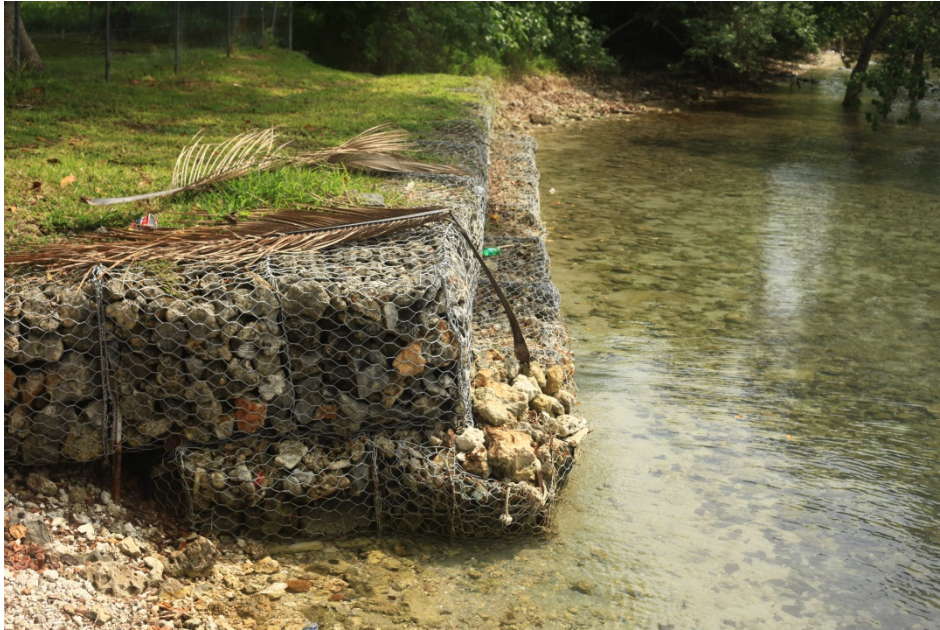
Figure 26 Gabions deteriorating due to lack of Geotextile membrane

As shown below the gabions are collapsing due to the sharp rocks cutting through the wire.

This is due to a lack of geotextile material being placed in the boxes before filling with stones. This is a design and construction error. The gabions can be repaired.

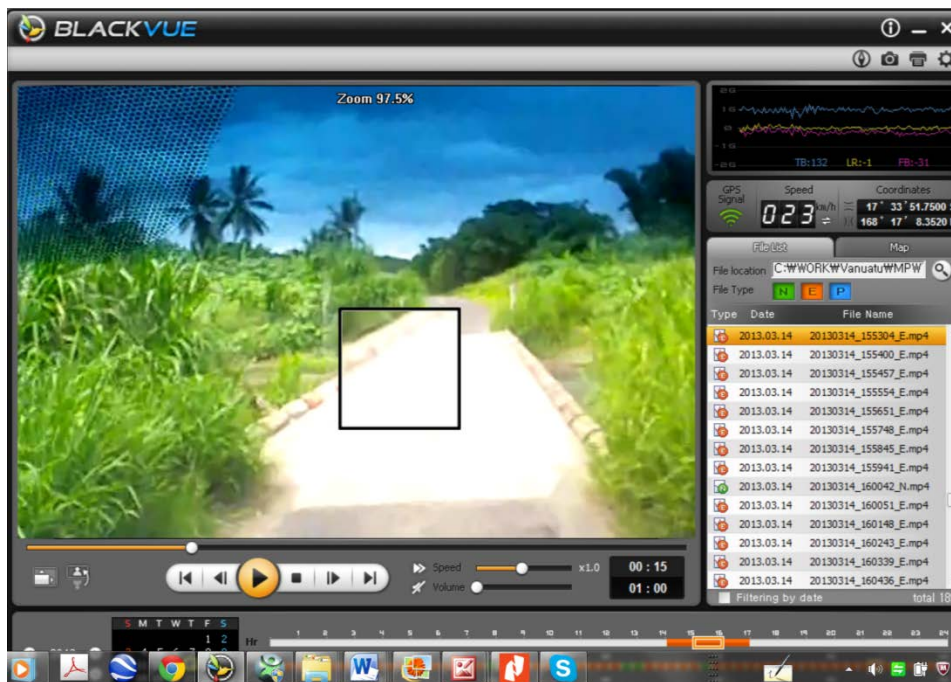
Figure 27 Vented Culvert Drift crossing

Vented drift crossings are very common on the Ring Road. One can see that vegetation is overgrowing the roads blocking site lines. Maintenance cleaning of the culverts is infrequent.

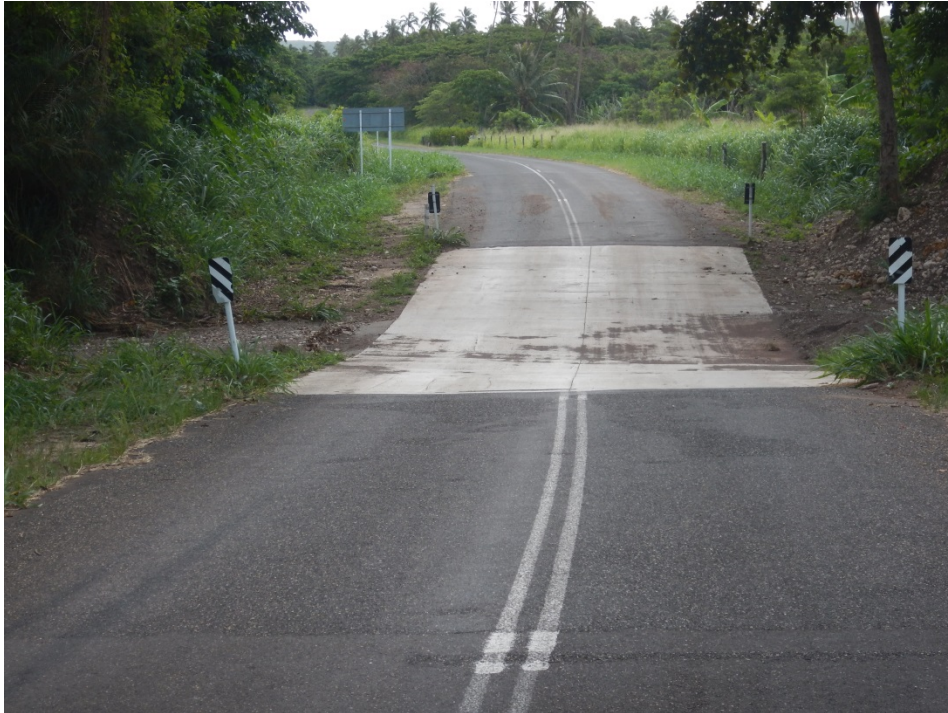
Figure 28 Lakenasua Unvented Drift Crossing

Lakenasua is probably the most vulnerable crossing on the Ring Road. It is the subject of a separate case study under CRRS. The outlet to the sea is about 300 metres to the right of the photo. To the left is a catchment area which has been identified under Manifold and using LiDAR files. It extends several kilometers into the hills and is a very large catchment. Flows across this drift are severe and cars have been washed away. The black and white warning signs give no indication as to what is a safe height to cross.

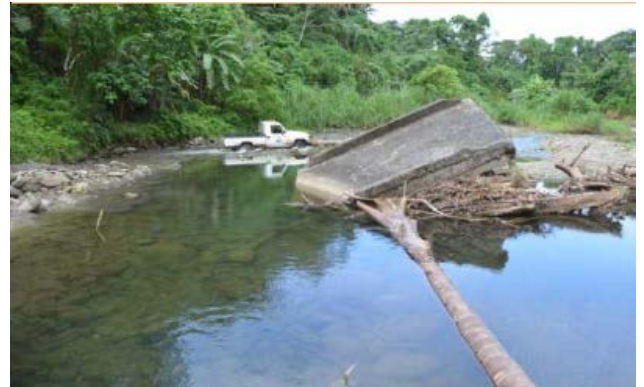
3. Wailo River

Type: River
Condition: No Bridge
Coordinates: 15 35'40.9680 S
166 54'0.8640 E
Blackvue File: 20150216_005819.mp4

25m wide river only passable by experienced 4WD truck drivers.

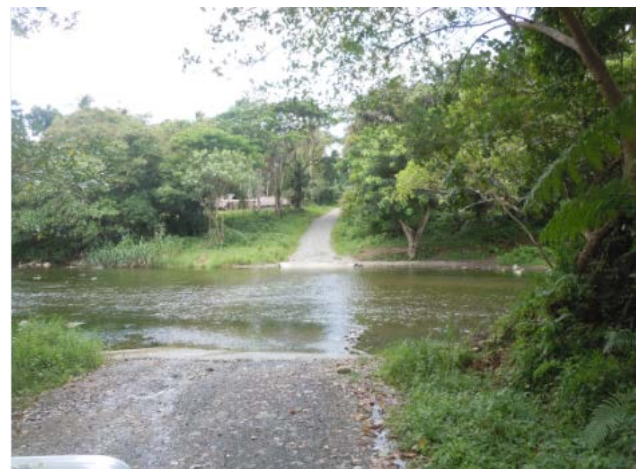
4. Navaka River

Type: River
Condition: No Bridge
Coordinates: 15 36'42.6420 S
166 52'8.9220 E
Blackvue File: 20150216_010935_E.mp4

A very large river. On normal days, the stream is 15m wide, but it can be 200m wide at the times of cyclone.

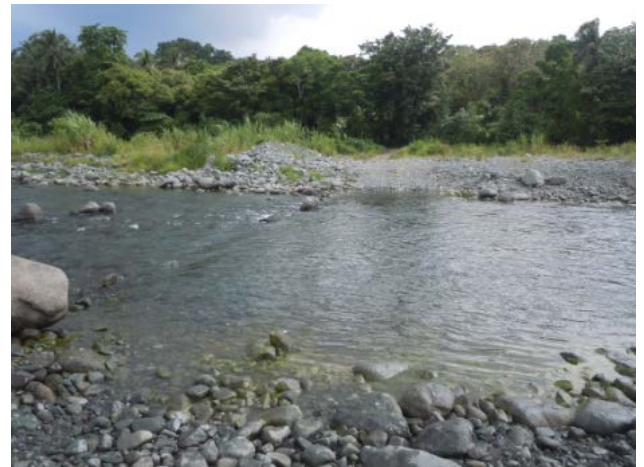
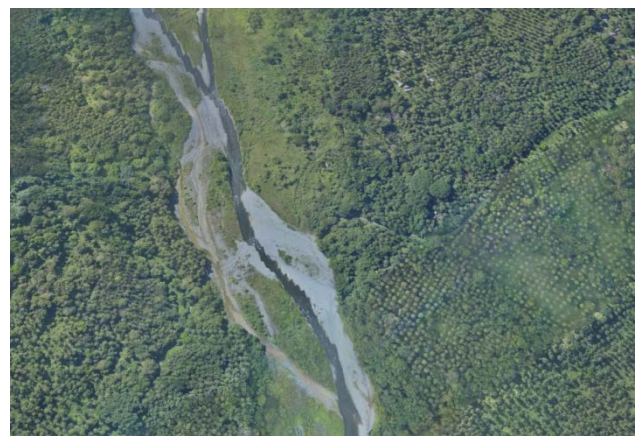
5. Buvo Bridge

Type: Bridge
Condition: Destroyed
Coordinates: 15 36' 27.2340 S
166 47' 5.9640 E
Blackvue File: 20150216_020913_N.mp4
River Width: 25m

A large river only passable by 4WD truck

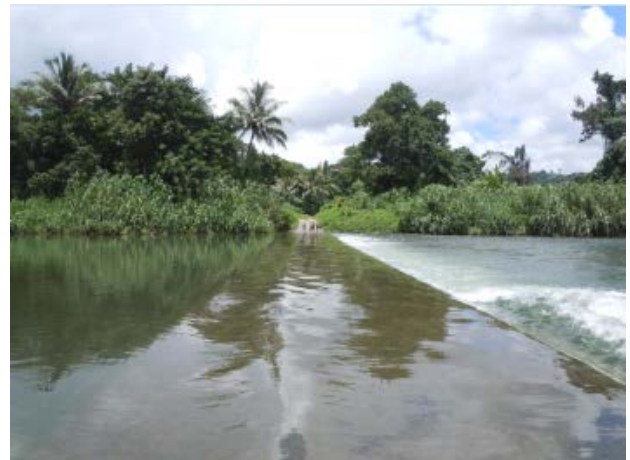
4. Jordan River

Type: River
Condition: No Bridge
Coordinates: 15 17'46.2960 S
166 52'21.6840 E
Blackvue File: 20150218_011512_E.mp4

The river is large and only experience 4WD driver can cross the river. The survey team was unable to cross this river.

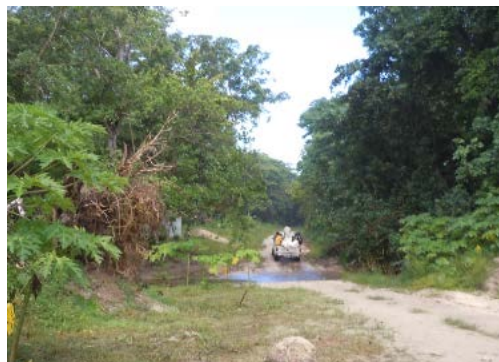
1. Seawater backs into the road

Type: Creek
Condition: Seawater backs into the road
Coordinates: 15 37'33.78 S
167 09'36.08 E

The road is approximately 45m from the sea. Crossing salt water can spoil the vehicles.

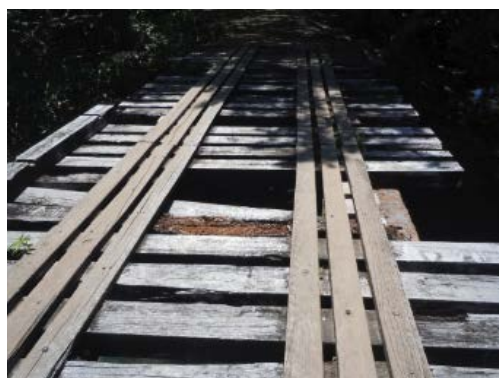
2. Bridge

Type: Bridge
Condition: Deteriorated
Coordinates: 15 37'49.66 S
167 11'03.40"E

Very old and deteriorated. Currently it is passable for light trucks; however it may collapse in the near future.

There is a bridge on a creek; however it is very old and replacement is recommended.

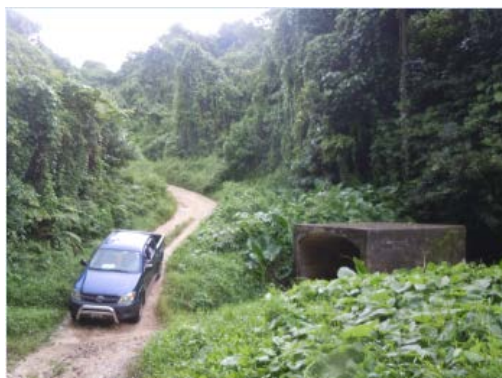
3. Box Culvert

Type: Culvert
Condition: Been displaced by the water
Coordinates: data error
A large box culvert has been displaced by the water, indicating the extreme strength of flash flooding.

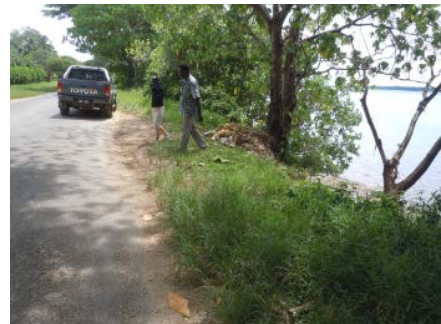
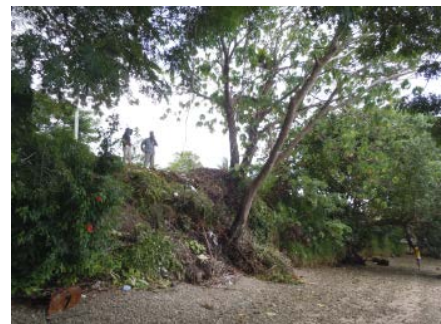
Type: Coastal Erosion
Condition: The sea has eroded the shore, and currently the shore is less than 10m from the road at the worst areas.
Coordinates: 15 32'39.57" S
167 08'56.10 E

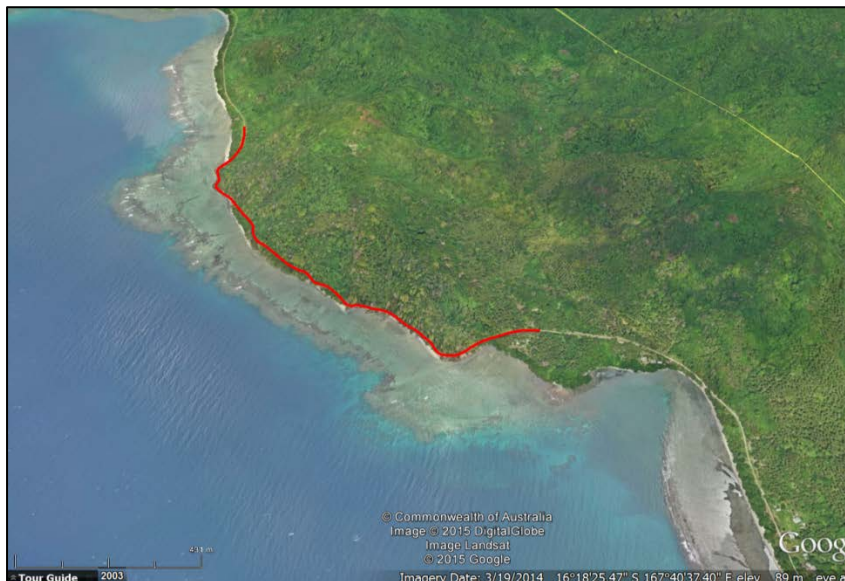
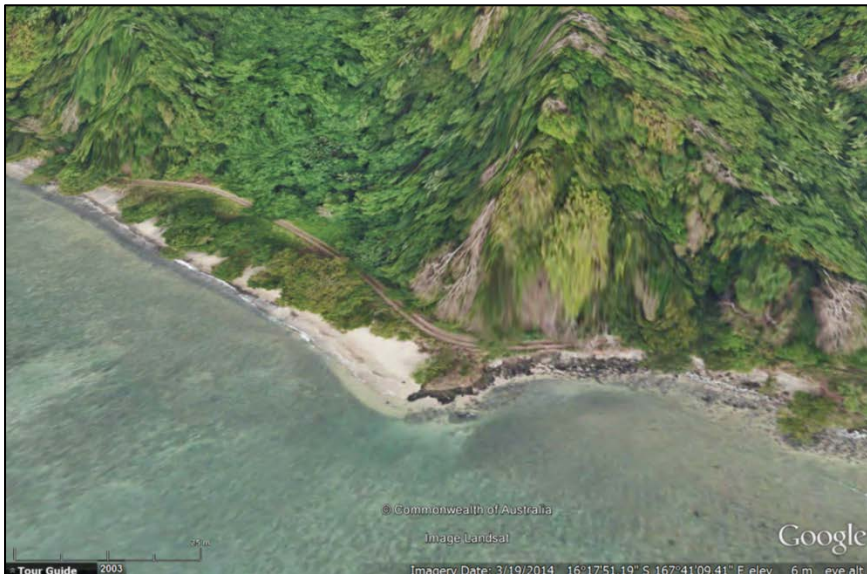
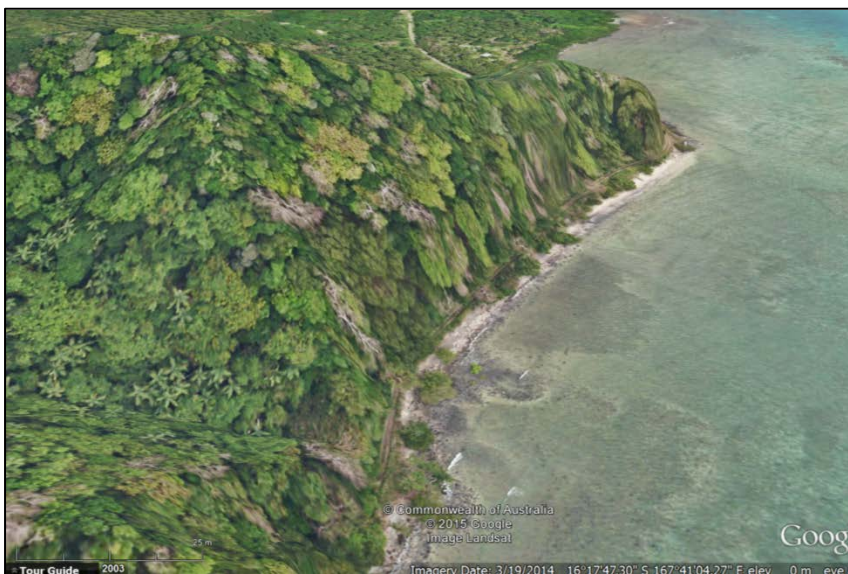
Figure 51 Assen Point Road

A major issue is Assen Point Road on South east Malekula. This road is suffering severe coastal erosion. It is the subject of a separate case study under CRRS.

Use has been made of LiDAR files supplied by Australian Aid / DFAT and views of the road demonstrating the severe erosion conditions are given below.

This allows a very rapid visual presentation to be made to decision makers. The conclusion is that remedial works will be exposed to severe weather conditions in the future and that relocation of the road to another alignment 1 km inland is the most cost effective solution.
