# Adaptation lessons from Cyclone Tracy

# **Historical Case Studies of Extreme Events**

## **Adaptation Lessons from Cyclone Tracy**

**Published by the National Climate Change Adaptation Research Facility 2010**

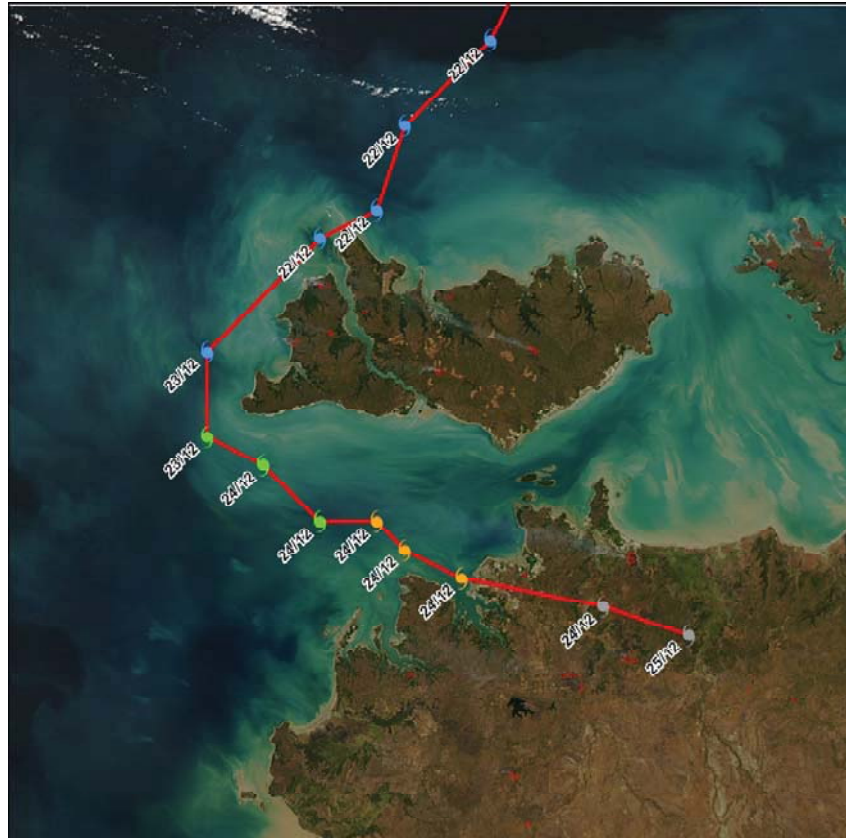
**Figure 1: Path of Cyclone Tracy through Darwin**

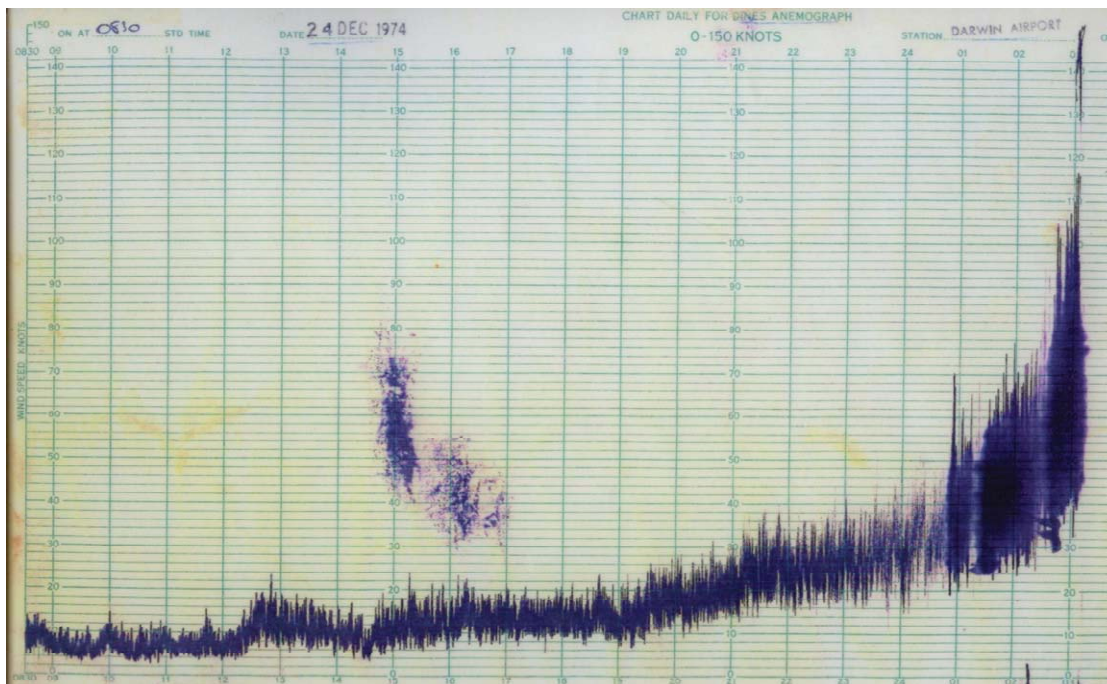
Figure 2: Dines anemograph from Darwin Airport – wind speed in knots

The time of anemometer failure correlates well with the arrival of the cyclone eye wall and the location of probable maximum winds for the storm. Wind speeds prior to the arrival of the eye (approximately 3.50 am) are not expected to have been significantly, if at all, greater than the recorded maximum at the site of the anemometer. Wind speeds equivalent to that at the time of failure persisted for only five minutes after the failure.

As previously mentioned, the peak recorded wind speed during Cyclone Tracy was 217 km/h (60 m/s) at the Darwin Airport. This measurement was made only minutes prior to flying debris destroying the anemometer. Wind speeds were recorded using a Dines Anemometer designed and calibrated for wind speeds up to 240 km/h (67 m/s) with a response suitable for capturing three-second gusts. The anemometer was positioned at an elevation of 10 m and located in approximately the centre of the airport. It is therefore reasonable to assume that wind speeds measured in this location are representative of Terrain Category 2 winds in the current, and all previous wind loading standards (Standards Australia 2002). Figure 2 shows the original Dines chart reading up to the time of failure, and is considered accurate to within 5 km/h (1.4 m/s). The spike in wind speed at the time of failure is the by-product of an electrical failure and is not considered real.

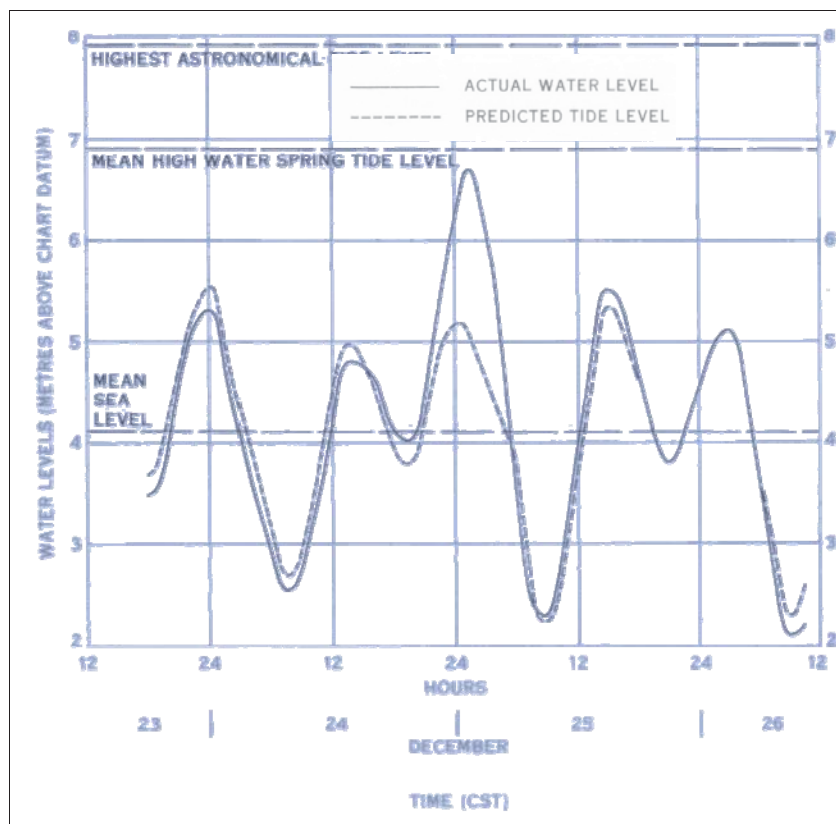
**Figure 4: Storm tide measured in Darwin Harbour. The difference between actual water level and predicted tide (in the absence of the cyclone) is due to the surge.**

Fortunately for the residents of Darwin, Cyclone Tracy occurred during a period of neap tide (low tide of the lunar spring neap tide cycle). This meant that even though Tracy was associated with a high tide, the water level did not rise enough to be of concern to Darwin, which has an approximately 8 m tidal range. The Darwin Harbour tidal gauge measurement trace is shown in Figure 4 for 23–26 December. A maximum measured surge of only 1.6 m is shown through comparison of the measured and predicted tide levels. The surge in Fannie Bay was also indirectly measured to be between 1.7 and 2.0 m (Commonwealth Bureau of Meteorology 1977). However, because Darwin Harbour and Fannie Bay were to the south of Tracy’s eye, these measurements are not representative of the maximum surge associated with the cyclone, which occurred to the left of the cyclone path (north), at Casuarina beach, where both wind and wave set-up were unimpeded. Field inspections of the area suggest the maximum surge height was 4 m above the predicted tide level (Commonwealth Bureau of Meteorology 1977). Had Tracy not made landfall at neap tide, but at the highest astronomical tide, inundation to 3 m with 2 m waves could have been expected in lower lying coastal regions (Commonwealth Bureau of Meteorology 1977). This would have caused further devastation to Darwin and posed significantly different emergency management issues.

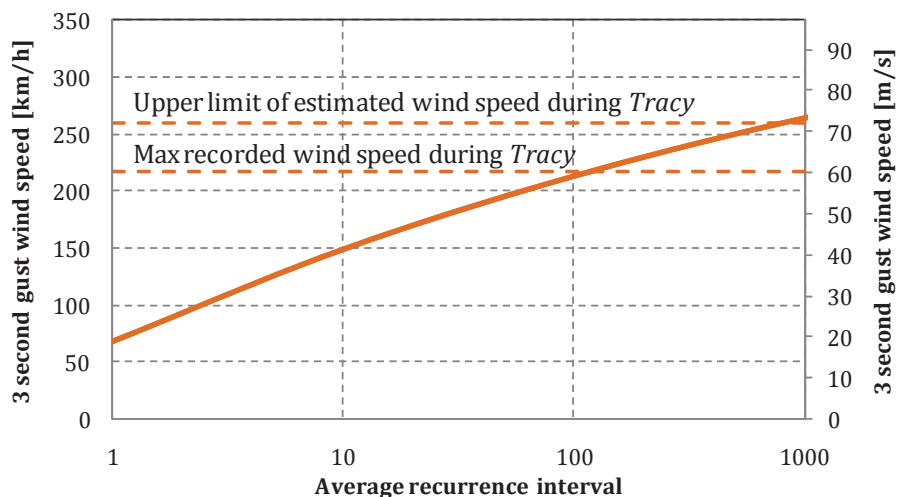
**Figure 7: Average recurrence interval (ARI) for gust wind speeds at a point location in Darwin** The upper limit is the maximum estimated wind speed estimated to have occurred at some point in the cyclone life, even though it did not necessarily impact Darwin.

Today, the understood wind risk in Darwin is not much different, with a gust wind speed of 213 km/h (59 m/s) prescribed as the 100-year return period wind gust in the current design standard for the region (Standards Australia 2002) (Figure 7). Some recent research suggests this may be too low, because the oceanic and tropospheric climate of Darwin could possibly lead to more severe events than historically observed (Cook and Nicholls 2009). This notion is in its scientific infancy, though, and its validity as applicable to Darwin is hotly debated (C Arthur, pers. comm., 29 October 2009; J Holmes, pers. comm., 3 December 2009; G Walker, pers. comm., 28 October 2009).

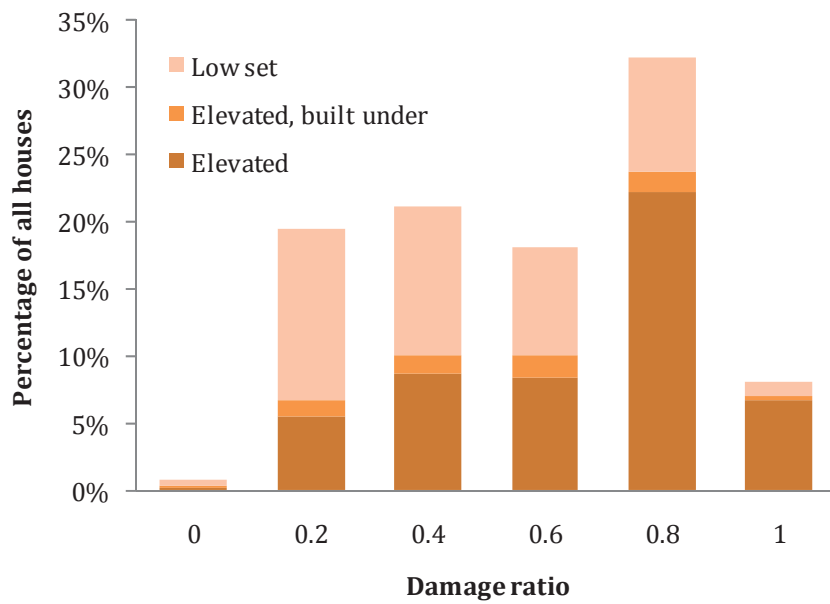
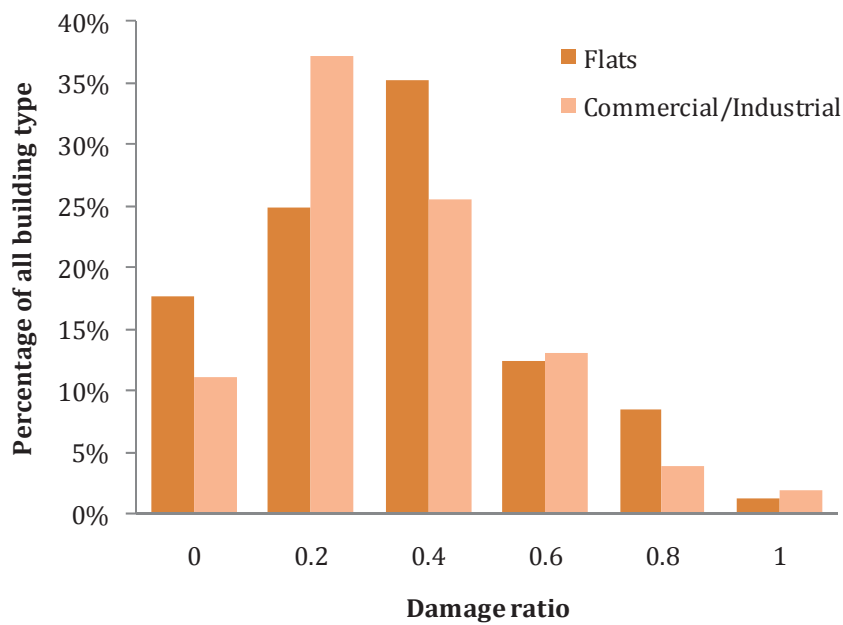
The damage distribution for the two categories of building is weighted more to the lower end of the damage scale, with flats showing a peak at 0.4 and commercial/industrial at 0.2. Both distributions drop steadily with increased damage. Comparing the number of destroyed buildings, (i.e. damage scale  $\geq 0.6$ ), with that of housing (60 per cent), a significant reduction is noted, with the flats (22 per cent) and commercial/industrial buildings (19 per cent) – that is, approximately one-third the level of housing damage. This reduction suggests not only an increase in structural strength of these building types, but also an increase in redundancy whereby even though 80–90 per cent of these structures suffered some form of damage, the buildings exhibited enough strength to avoid total collapse. This was not always the case, though, with Baker and Walker (1976) describing some types of steel-framed structures that performed poorly due to a lack of redundancy in their design. On a more positive note, the comparatively low number of engineered structures that suffered complete failure is encouraging given that the wind speeds experienced by many of these buildings was higher than that used in their design (Baker & Walker 1976). It is also a justification of the use of engineering input, as opposed to intuition and experience alone, in the design and construction of buildings.

**Figure 11: Damage statistics for (a) residential houses and (b) flats and engineered buildings collected by the Department of Housing and Construction survey**

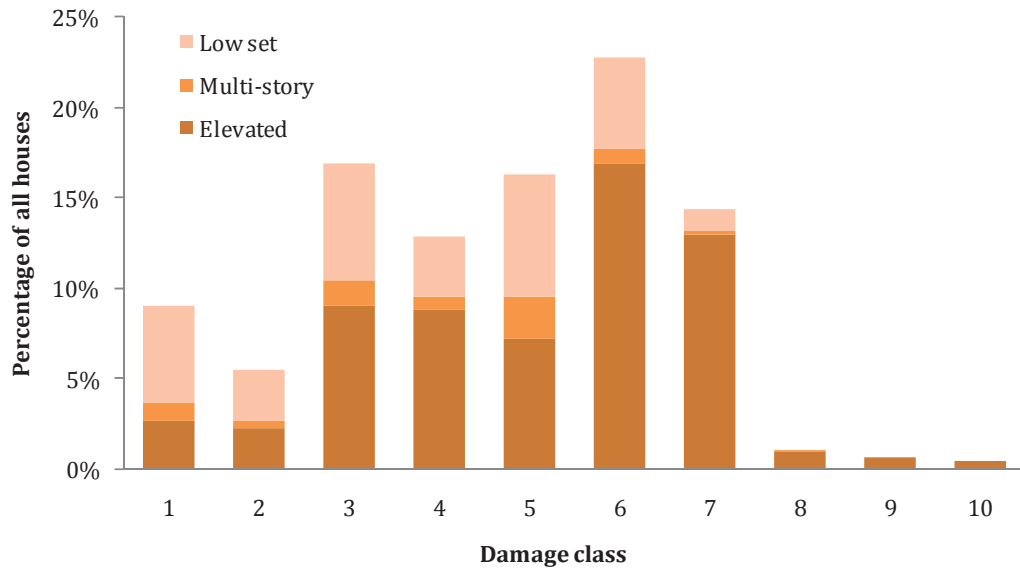
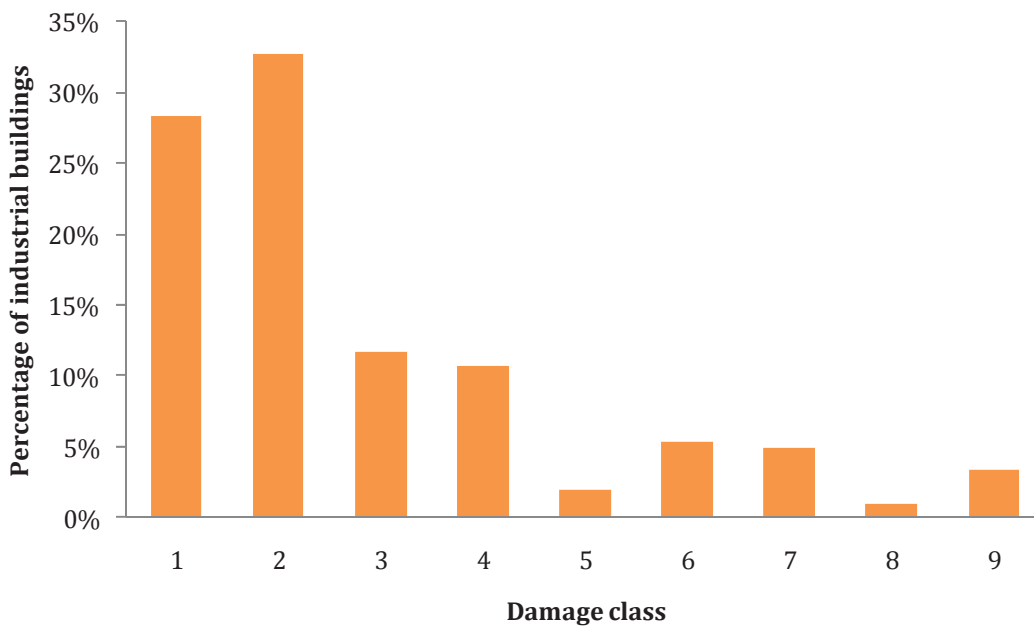
This suggests that the most populous failure class was loss of all roofing and approximately half the wall structure. In general, this agrees with the DHC survey. One difference between the two surveys is the amount of housing that experienced negligible damage. Figure 12(a) shows about 9 per cent of homes in this category, while Figure 11 shows only about 1 per cent of homes. It is perhaps not surprising that differences would appear at the lower end of the damage spectrum, given that a negligible level is somewhat subjective. Class 0 may have also been applied to the CSIRO survey if only minor wind pressure damage (i.e. not due to wind borne debris impact) was evident in, say, the loss of a single roof sheet, whereas this could have drawn a damage percentage of 0.1 (aggregated with 0.2 here) in the DHC survey. Irrespective of these differences, single-digit percentages of negligible damage imply a poor performance from the housing stock.

**Figure 12: Damage statistics for (a) houses and (b) industrial (engineered) buildings collected by the CSIRO survey**

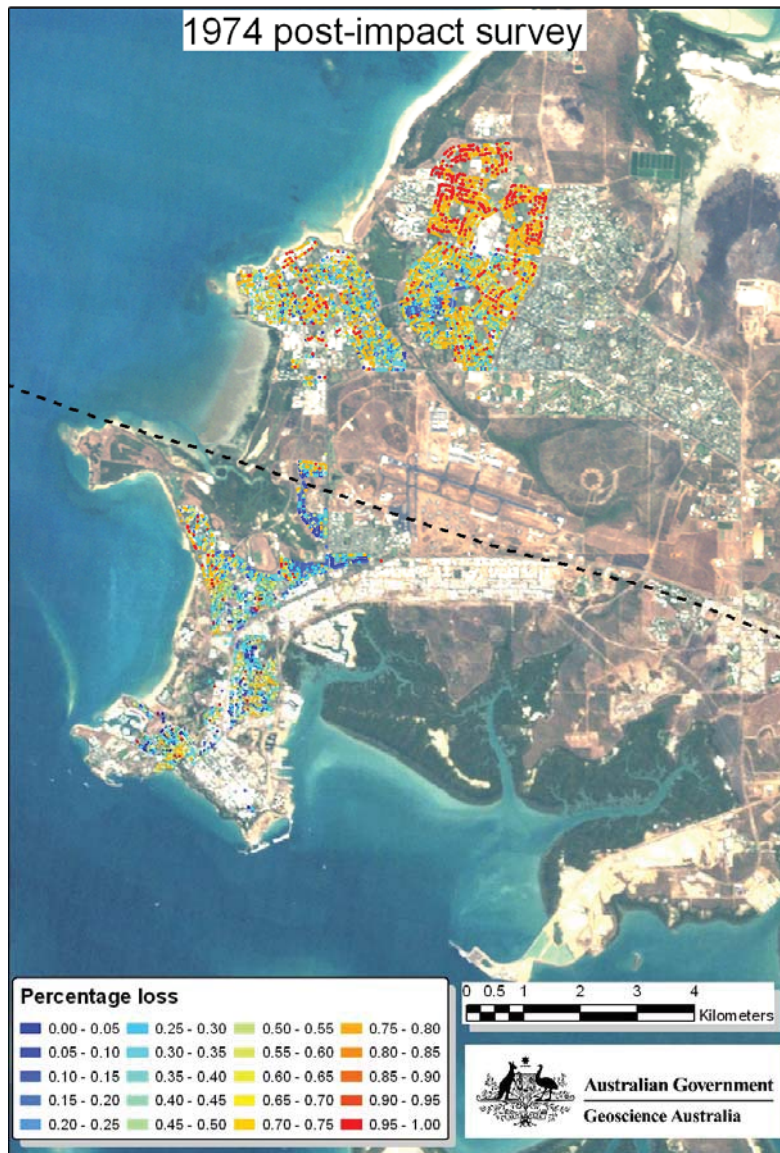
To determine the spatial distribution of damage throughout Darwin, the damage ratios for each residential structure, based on the DHC damage survey, are plotted in Figure 13. A distinct northern suburbs (and therefore north of the eye) bias is evident, with the northern most suburbs of Nakara, Tiwi and Wanguri being worst impacted. Arithmetic averaging of damage percentages over the suburbs to the north and south of the eye reveals average ratios of 0.62 and 0.42 to the north and south respectively. The increased basic wind speeds to the north, noted in Figure 3, in part defined this distribution, but this does not explain the near-complete destruction of the northernmost suburbs (Walker 1975).

**Figure 13: Distribution of damage percentage ratios based on the DHC damage survey**

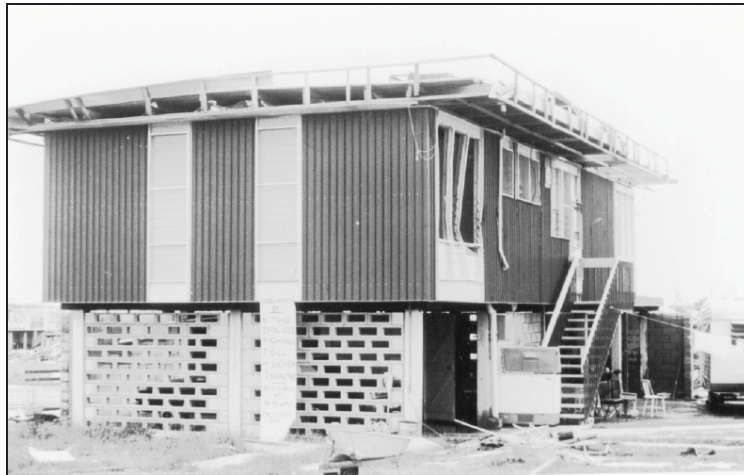
On larger buildings, and with a small number of homes, corrugated iron or ribbed metal was used for cladding and performed comparatively well. The reason for this was its ability to plastically deform when impacted by flying debris without tearing (Figure 18). This meant structures maintained their rigidity even when roofing was lost.

**Figure 18: Survival of a house clad in sheet metal**

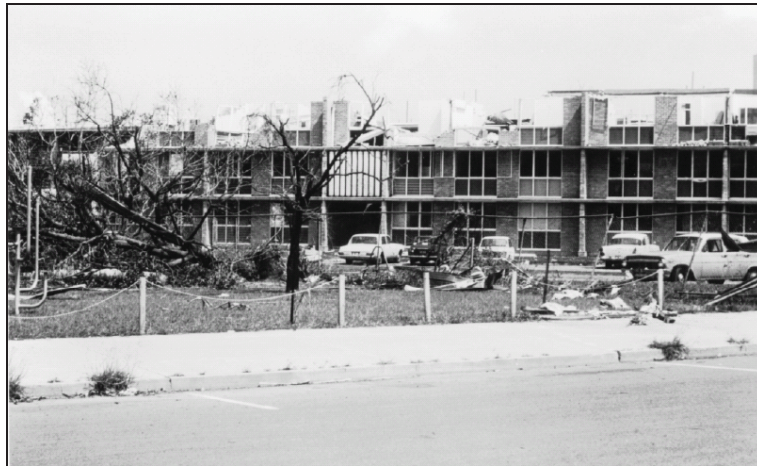
Structures that required an engineer to certify their structural capacity performed well (Section 0). Of those that did fail, more often than not this was ascribed to inappropriate application of design standard concepts. This generally came about because of inadequate explanation in the standard. A by-product of this was generally the application of a design wind speed well below the probable wind speeds experienced during Tracy. A prominent example was the use of terrain category 3 (well built up or vegetated areas) in regions that were severely de-vegetated by the extreme winds and more appropriately would have been classified as terrain category 2. A second example was the design of structures with large roller doors as nominally sealed buildings. Given the discussion in Section 0 on the poor performance of these doors, not clearly specifying that roller doors, unless designed to withstand wind and debris loading, as potential openings was inappropriate.

**Figure 19: Failure of the top level of a block of flats**

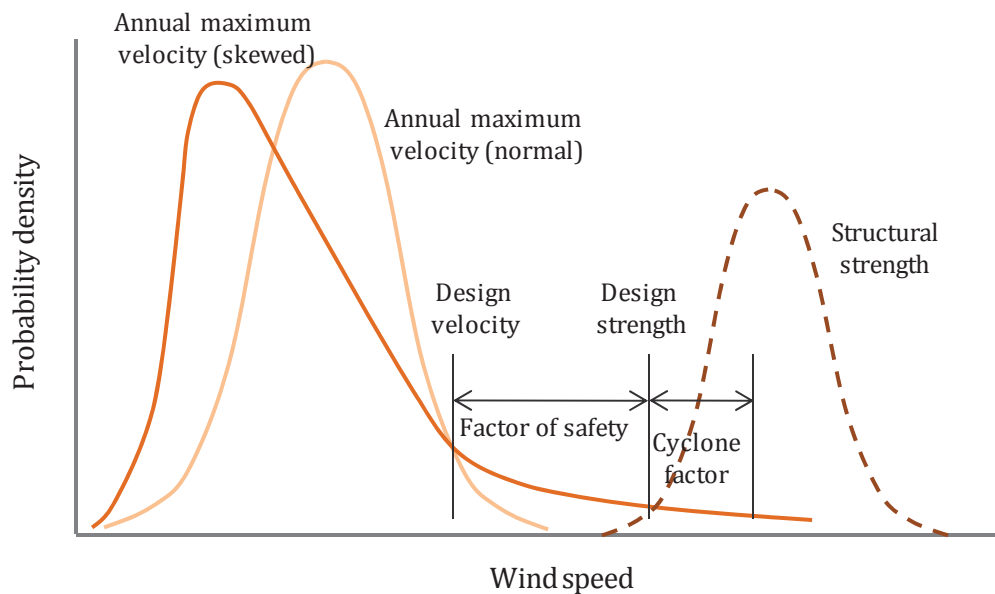
however, the wind speed distribution extends well past what would be set for the design wind speed (e.g. the 50-year return period gust) (see Figure 21). Therefore, simply applying a factors-of-safety derived based on a normal type distribution could not ensure that significant structural failures (i.e. design strength exceeded) would not occur during extreme events. This fact was realised by engineers, and an additional factor of safety – the cyclone factor – was applied in practice.

**Figure 21: Interaction between wind speed and strength for normal and long-tailed distributions**

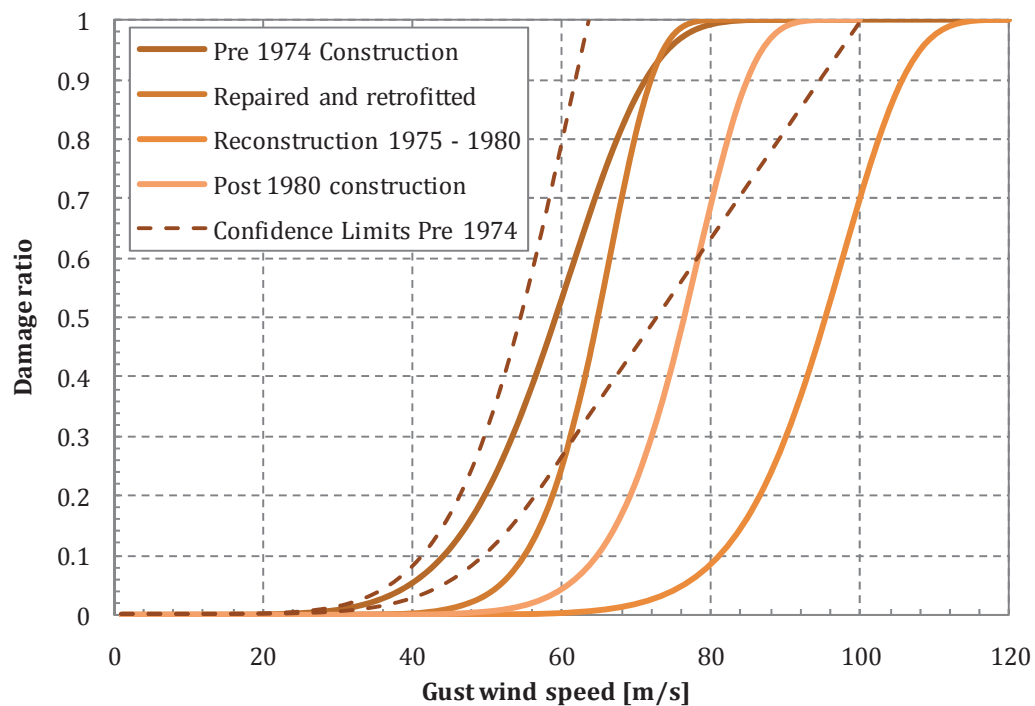
As in the normalisation method discussed in Section 7.1, wind speed is related to building damage through vulnerability curves (Figure 23). For the 1974 scenario, only a single loss curve is applied, but given the significant changes made to building design and construction since that time, a suite of curves are utilised for the 2008 scenario.

**Figure 23: Vulnerability curves used for the scenario loss model. Only the average curves were used in the scenario analysis discussed in the text.**

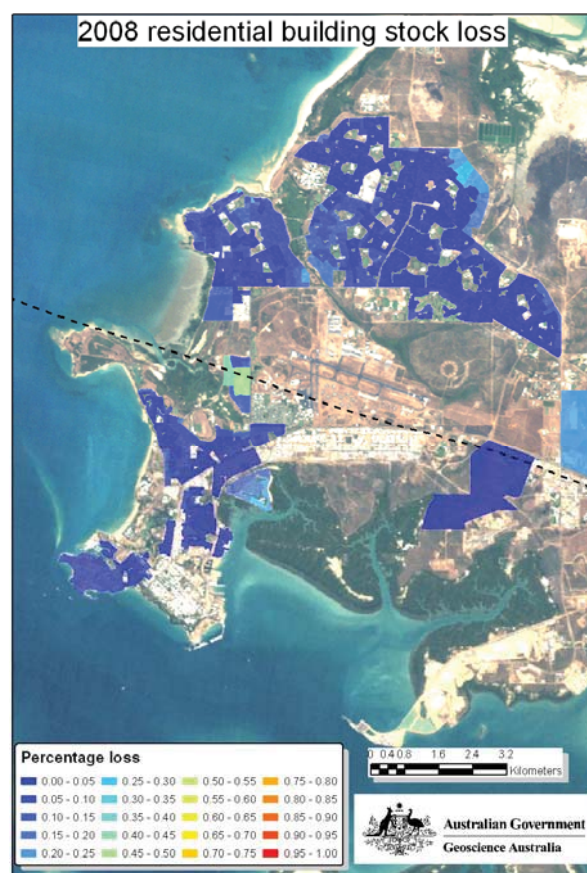
Performing the scenario loss analysis for 2008 societal conditions, the Darwin averaged damage ratio is calculated as 0.035, with a spatial distribution shown in Figure 26. A simple damage ratio comparison shows a drop in averaged damage ratio of 90 per cent. Given that the number of buildings and average building value is much greater in 2008, this value *does not* represent a 90 per cent reduction in monetary losses. Arthur et al. (2008) also highlight that because of Tracy's small size and Darwin's inland spread, many of the newer suburbs would not have experienced the full force of the wind. Therefore, to isolate the influence improved building standards have had on resilience, only damage ratios for the 1974 footprint were compared with damage survey results. In doing this, the averaged damage ratio becomes 0.052, a reduction of 85 per cent from the 1974 results. These reductions are significant, once again suggesting that the improvements made to the wind loading standard would significantly improve the structural performance in the event of a recurrence.

**Figure 26: Damage ratios for 2008 societal conditions**

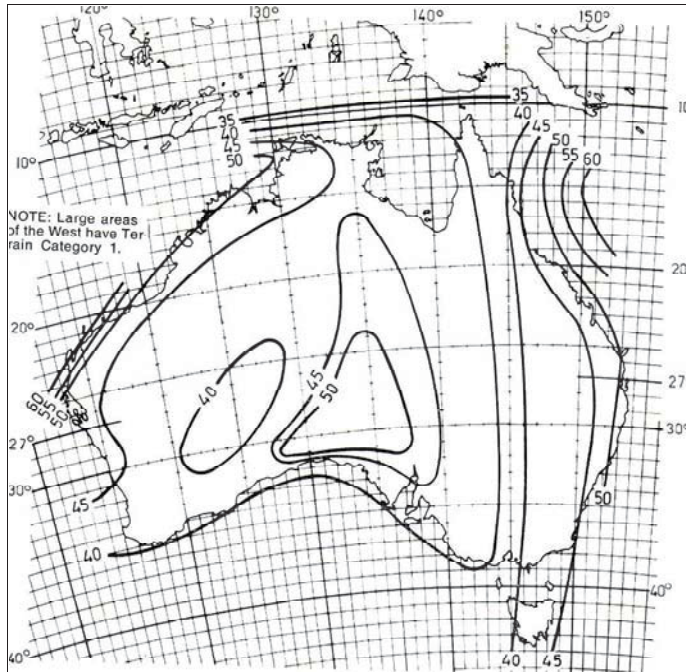
Figure A1.2: AS1170 Part 2, 1973
