Vulnerability Mapping Report

Climate Resilient Road Standards (CRRS) Project Phase 2

For: Department of Environment (Australia)

February, 2015

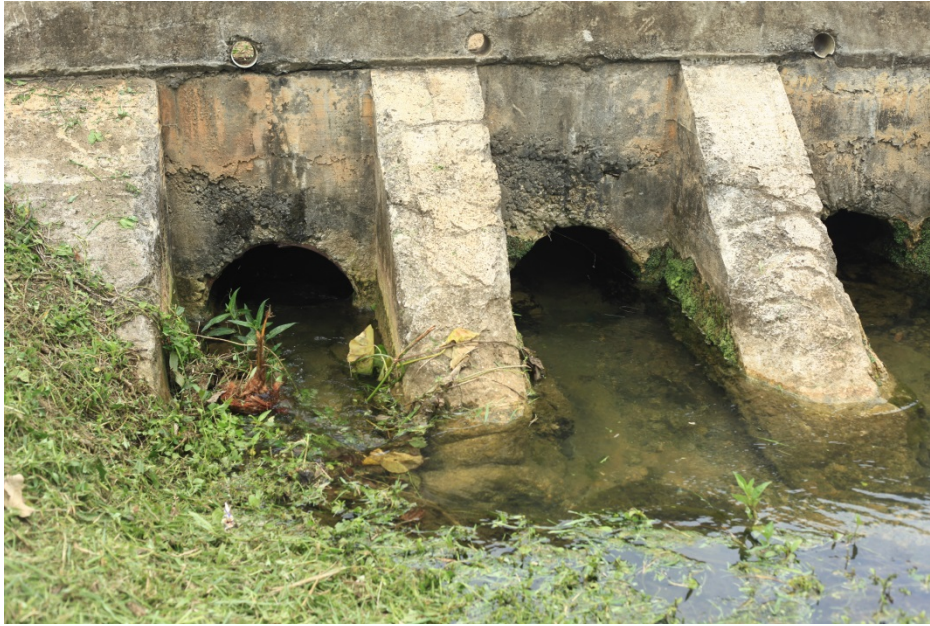
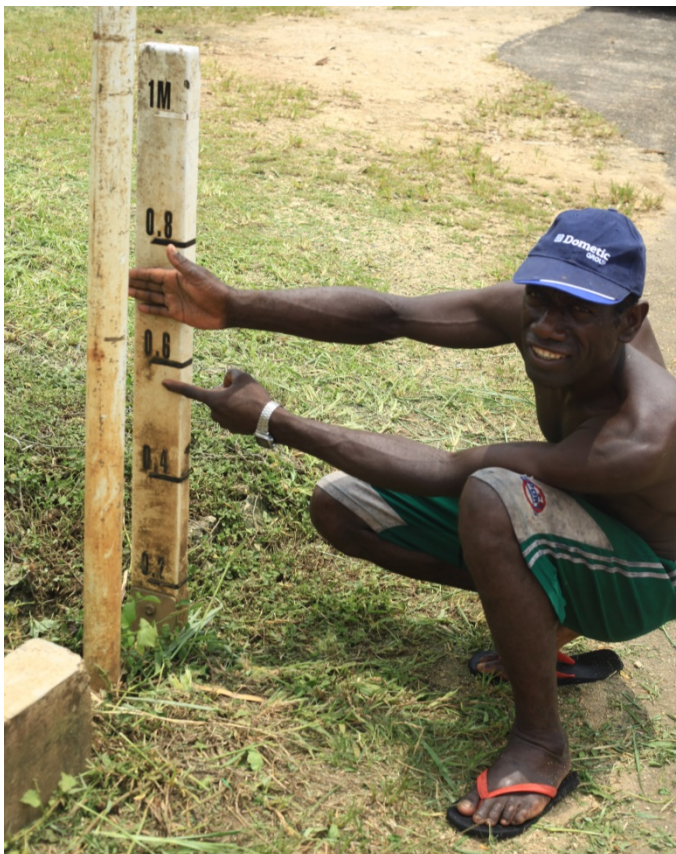
Figure 18 Very Small Culverts

Figure 19 Height of Floodwaters

The figure above shows that the culverts in the bridge are of small diameter. These impede the water flow and are prone to rapid silting.

Larger pipe culverts or larger box culverts allow a faster water flow and so are self cleaning.

This bridge cannot be changed but the lesson learned should be used in future designs. More regular maintenance cleaning is required.

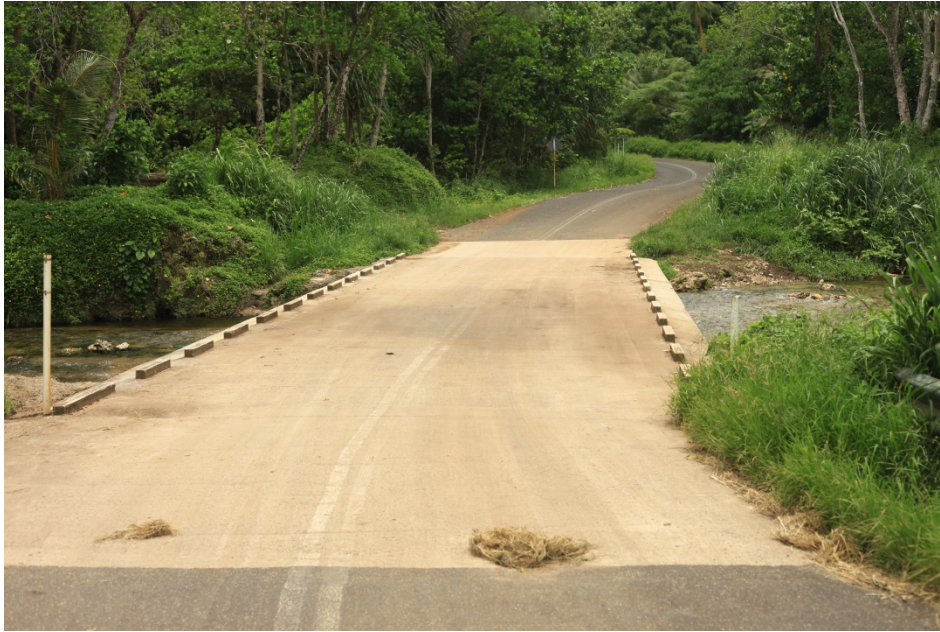
Figure 20 Vented Road crossing with concrete safety blocks

This is a vented drift. Note the difference in height between upstream (right hand side) and downstream (left hand side) flows. The vents are impeding the flows.

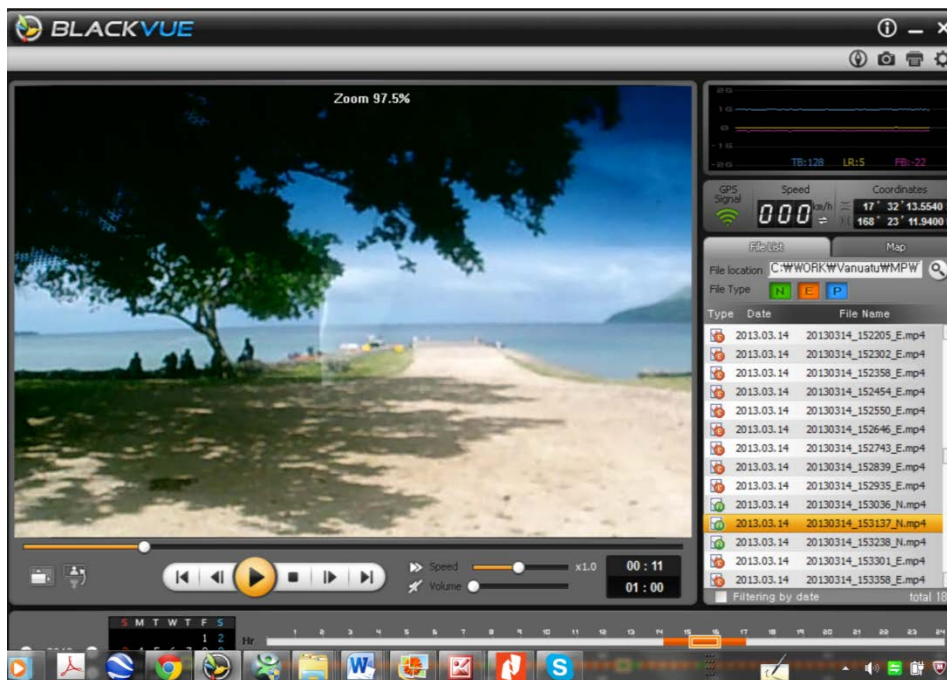
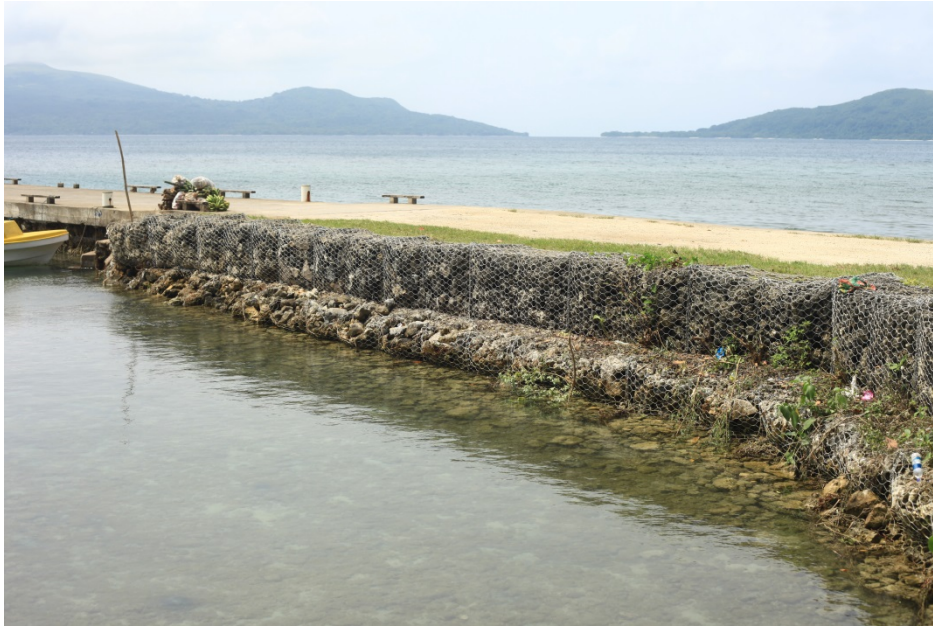
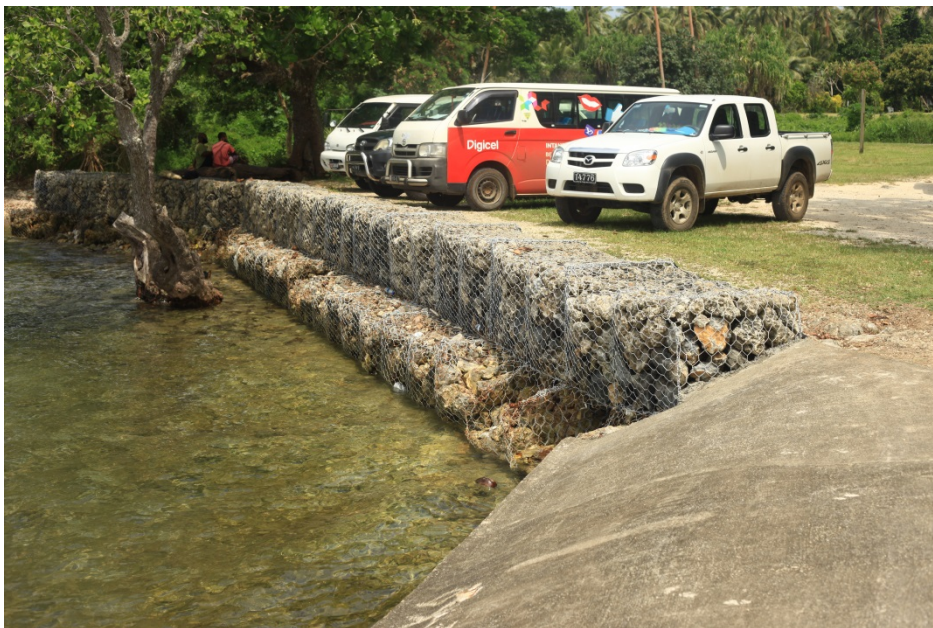
Figure 23 Emua Wharfe Ring Road

Figure 24 Emua Wharfe Ring Road

Figure 25 Emua Wharfe Ring Road

This is due to a lack of geotextile material being placed in the boxes before filling with stones. This is a design and construction error. The gabions can be repaired.

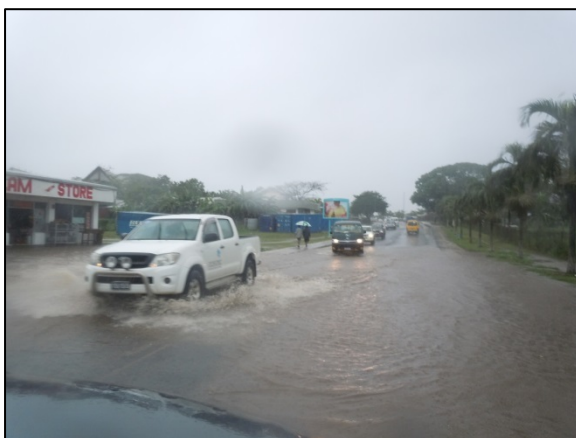
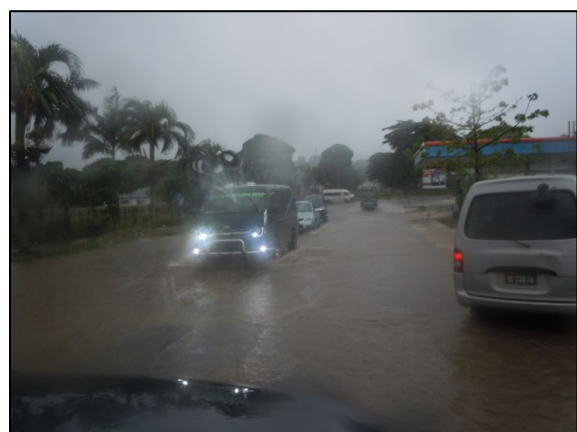
Figure 29 Manples Junction Flooding

It floods on a regular basis being impassable on a monthly basis. It was the subject of a separate case study under CRRS. It is included for improvement under the Port Vila Urban Development Project. CRRS have provided rainfall data for project climate change scenarios to the PVUDP team.

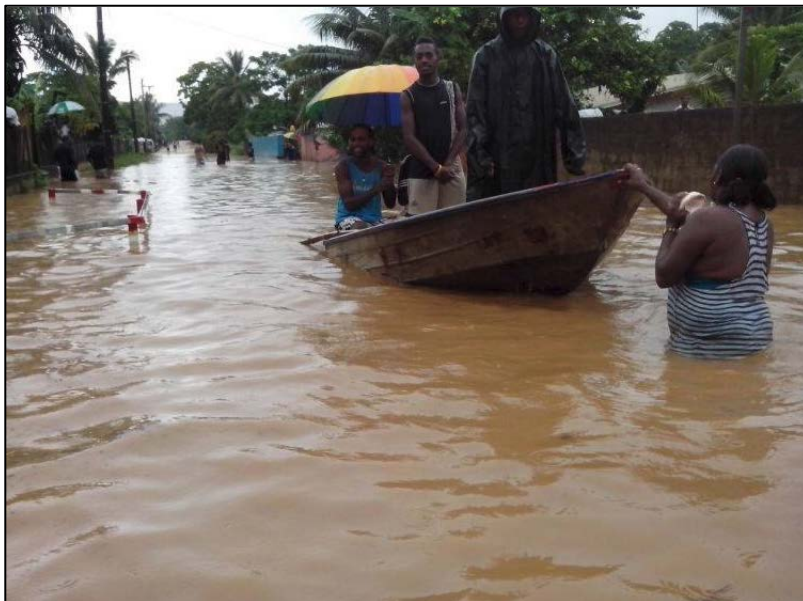
Seven Stars lies above Manples Junction and flows from here contribute to flooding in Maples. The MGHG reported that this rainfall was the heaviest in Port Vila for the first two months of 2015. Bauerfield International Airport recorded 85.2mm of rain in a 24 hour period.

Figure 30 Seven Stars Flooding

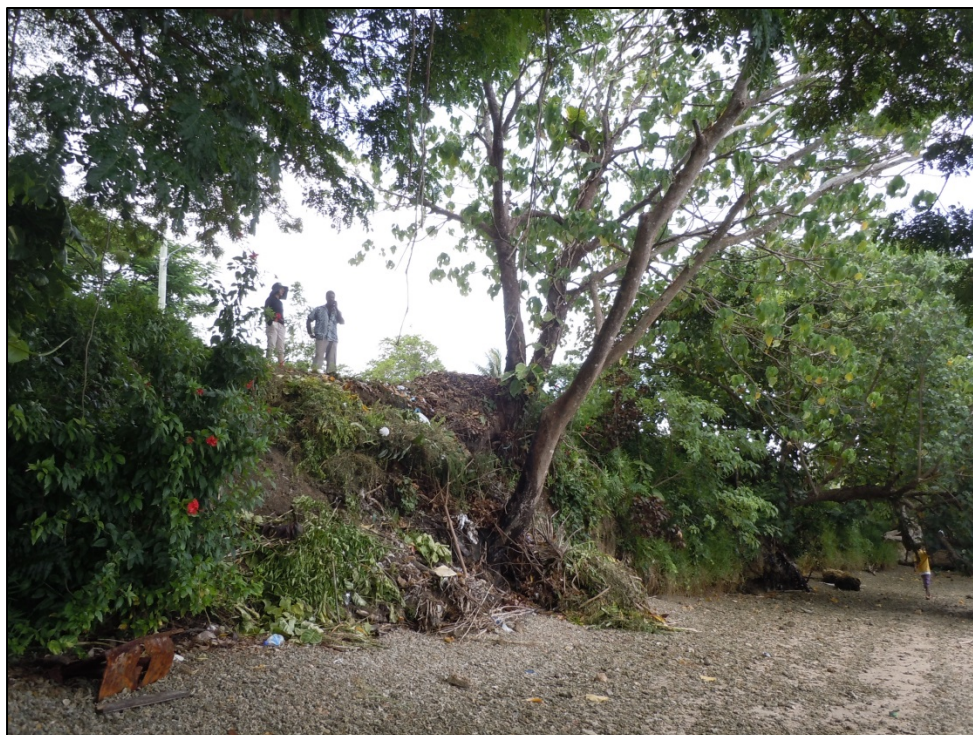
Figure 43 Erosion near Coral Quay

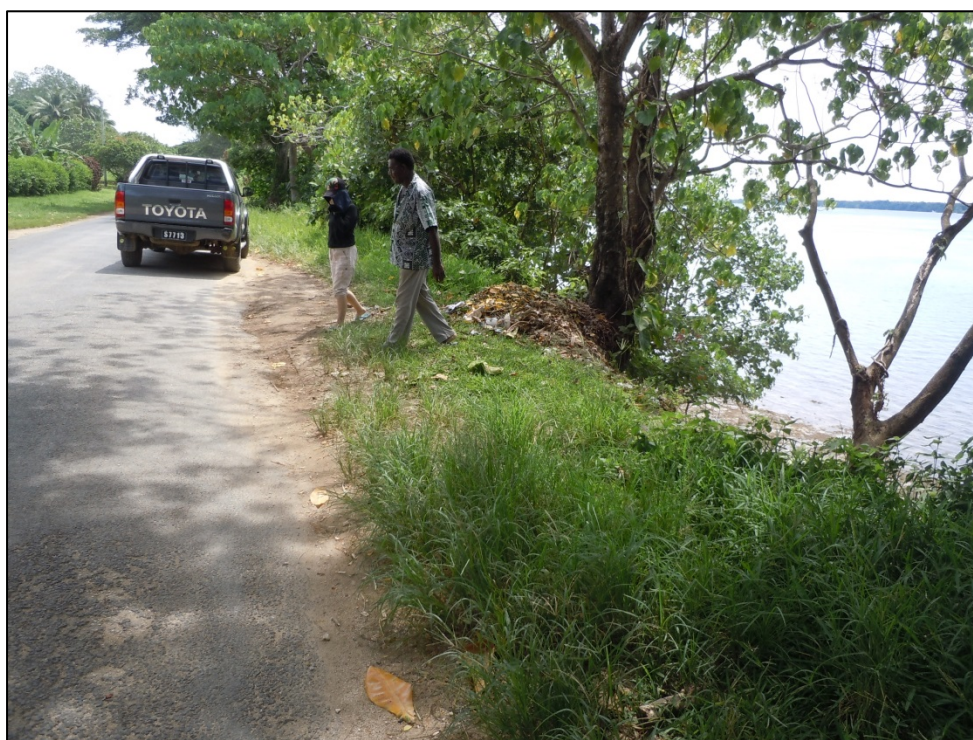
Figure 44 Erosion near Coral Quay

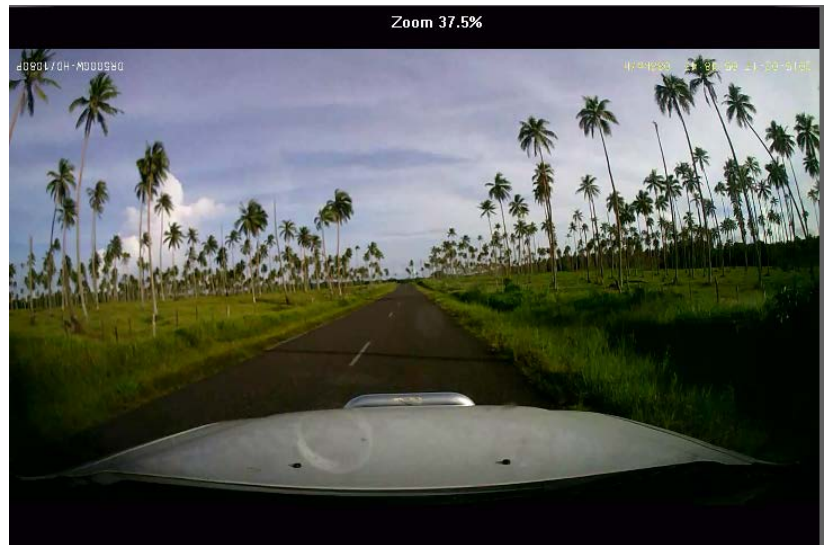
Typical view of R1 Road

This road has been built by the U.S.A. recently, the condition is excellent. Typical travel speed is 80-100km/h, indicating the road condition is very well.

No significant area vulnerable to climate.

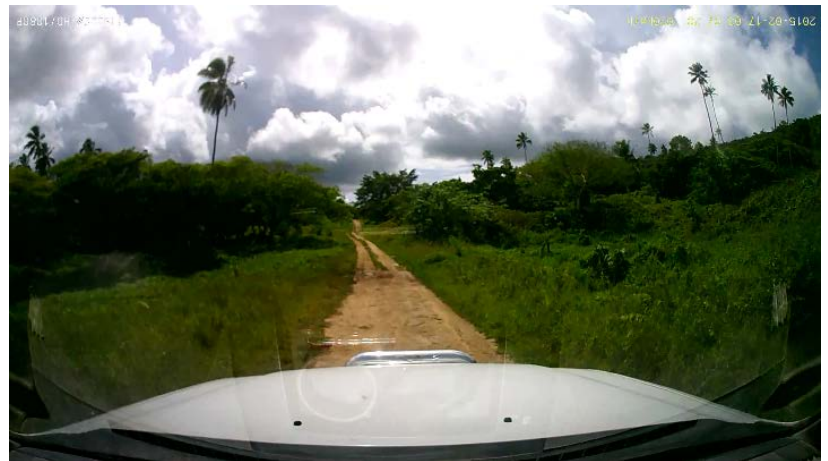
Typical view of R1.2 Road

This is an unsealed road connecting the North Eastern communities to Port Olry.

Condition is rough to fair, but is not significantly vulnerable to climate change.

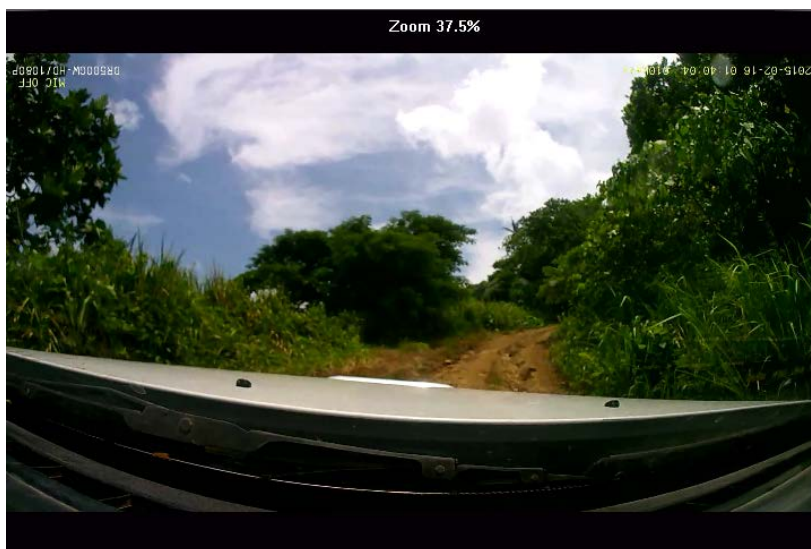
Typical view of R2 Road

This is the main route for communities in South Santo. A great number of population utilizes this road for traveling and transporting commercial goods such as copra.

This road is highly vulnerable to climate impact mostly due to lack of bridges. There are a number of rivers and creeks crossing the road, and many of them are impassable at the times of heavy rain.

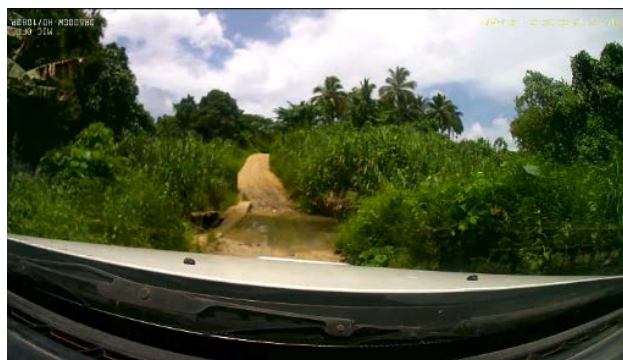
Type: Concrete Slab with culverts
Condition: Damaged.
Not passable when the water level rises due to heavy rain.

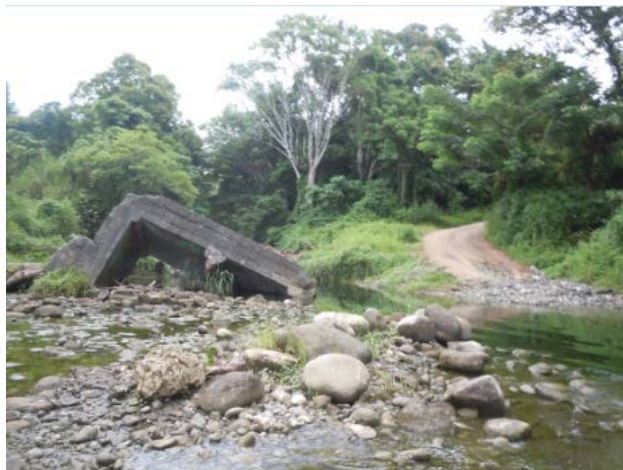
2. Manniao Bridge

Type: Bridge
Condition: Destroyed
Coordinates: 15 34'13.2360 S
166 56'49.4820 E
Blackvue File: 20150216_003511_E.mp4

River width: 20m

The destroyed bridge indicates the strength of the river at the times of flash flooding. Only experienced 4WD truck drivers can pass this river.

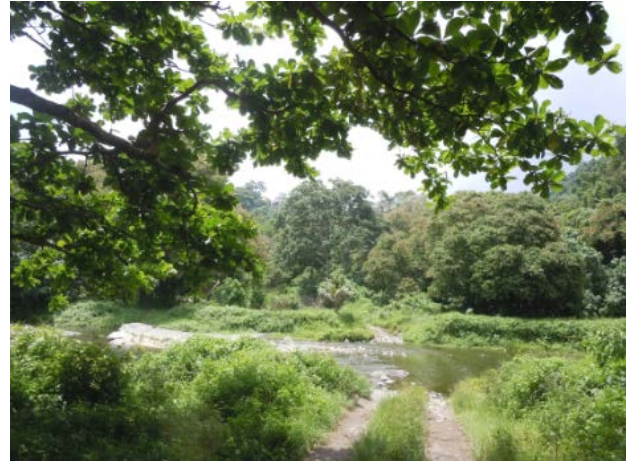
Type: Bridge
Condition: Destroyed
Coordinates: 15 36' 27.2340 S
166 47' 5.9640 E
Blackvue File: 20150216_020913_N.mp4
River Width: 25m

A large river only passable by 4WD truck

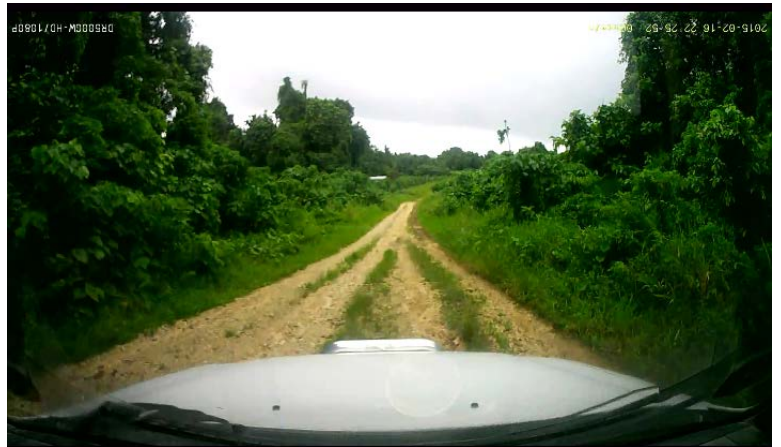
Typical view of R3 Road

This road connects Matantas Village to R1. The condition is overall poor; however there are no places significantly vulnerable to climate, and the basic access is maintained.

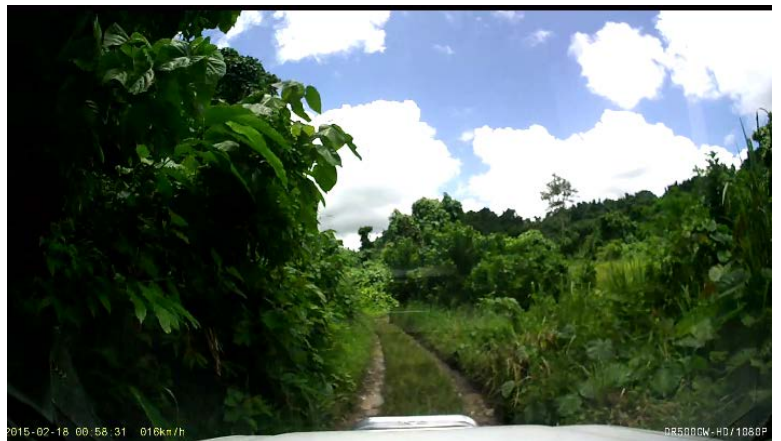
Typical view of R4 Road

This road connects Big Bay and other small communities to Luganville. The hilly terrain makes the traveling difficult, and the second of the three large rivers was impassable for the survey team.

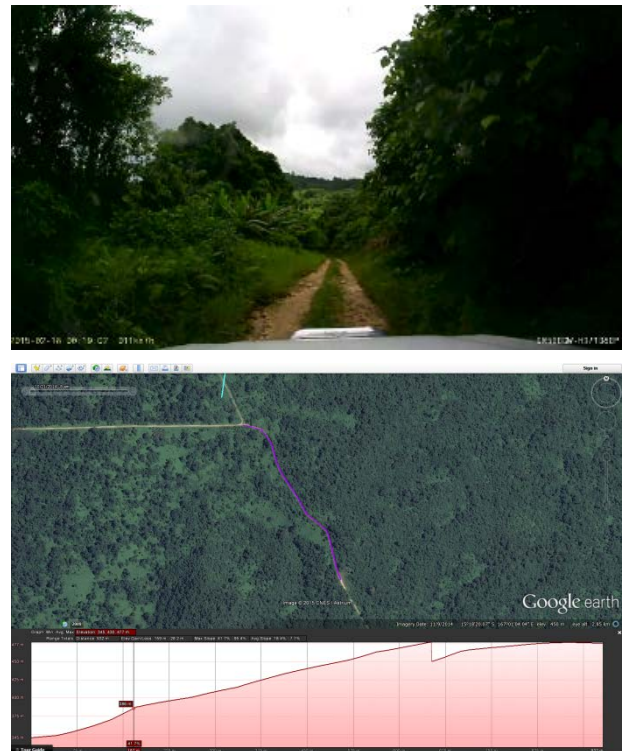
1. Glass Hill

Type: Hill
Condition: Very Rugged
Coordinates: 15 18'13.4400 S
167 00'57.3960 E
Blackvue File: 20150218_001852_E.mp4
Max Slope: 41.7 %? (Google Earth)
Elevation Difference:
132m?

Many drivers now choose to drive on R5 and avoid this hill.

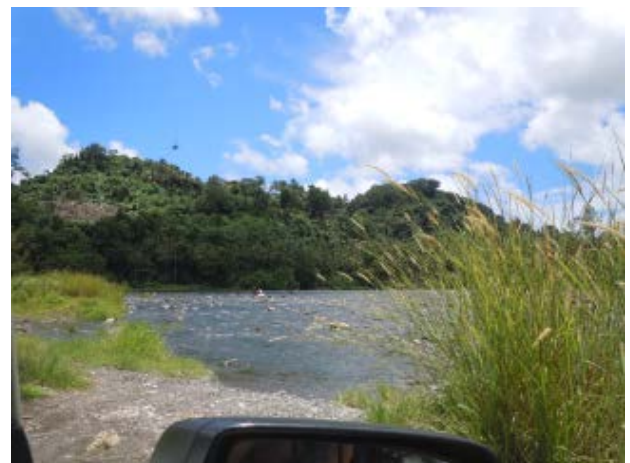
Type: River
Condition: No Bridge
Coordinates: 15 17'46.2960 S
166 52'21.6840 E
Blackvue File: 20150218_011512_E.mp4

The river is large and only experience 4WD driver can cross the river. The survey team was unable to cross this river.

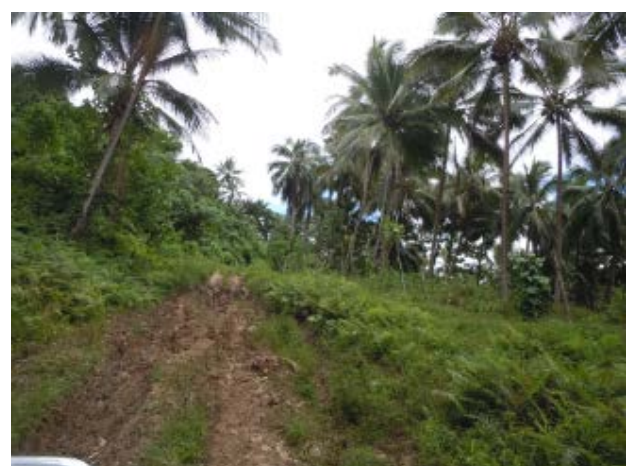
5. Jordan River Hill

Type: River
Condition: No Bridge
Coordinates: 15 17'57.8700 S
166 52'31.9500 E
Blackvue File: 20150218_012200_E.mp4

The hill was very slippery as the roadbase has been dug out. The rutting was very deep, and the survey vehicle did not have high enough clearance.

This hill is **highly vulnerable** to climate change impact.

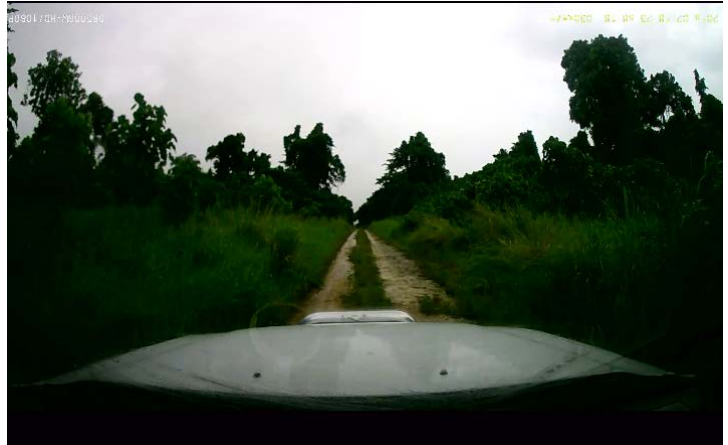
Typical view of R5 Road

This is an important route for R4 users as it serves as a bypass for the rugged R4 road. Drivers can connect R1, R3, and R5 in order to reach communities on R4 road.

Condition is rough, but basic access is maintained.

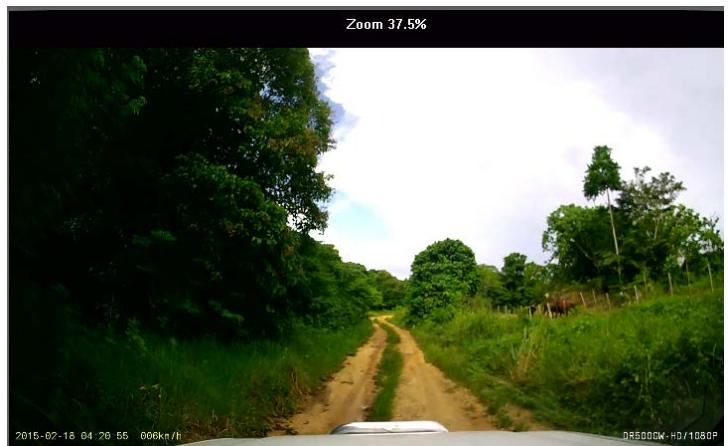
Typical view of R6 Road

This road is a shortcut for R4, as it connects R4 to R1 at Turtle Bay area. There are no rivers or extremely steep hills. The basic access is maintained; however, the condition is very poor and repair work is recommended.

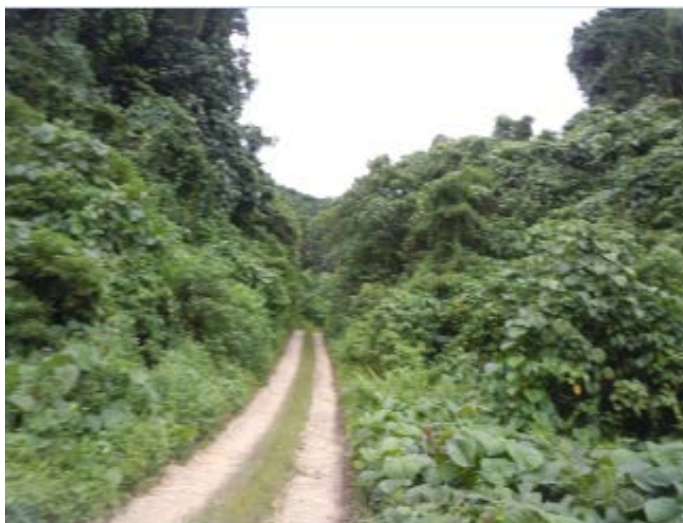
Typical view of R7 Road

Overall Malo roads are in the fair condition. There are two creeks that crosses the road, and when the tide is high, the sea water backs into the road.

There is a bridge on a creek; however it is very old and replacement is recommended.

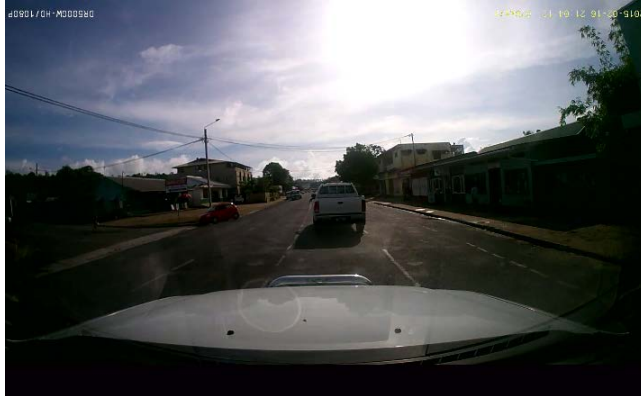
Typical view of Luganville

Roads in Luganville city are a mix of sealed and unsealed roads.

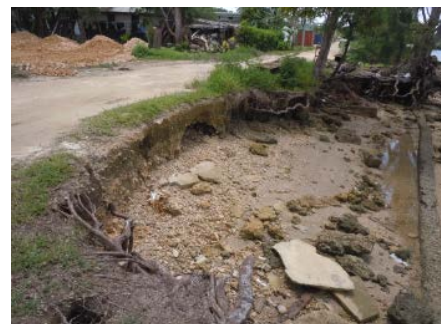
Type: Coastal Erosion
Condition: The sea has eroded the shore, and it is about to reach the road.
Coordinates: 15 30'54.24 S
167 10'43.11 E

Erosion at the shore is visible throughout the city. Ruins of the structures from the WW II era can be seen everywhere.

This is a back road, and not a primary route.

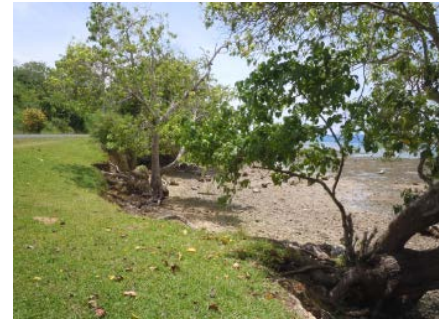
3. Near Pacific Petroleum

Type: Coastal Erosion

Condition: The sea has eroded the shore. The worst area is about 10m to the road.

This is a main road connecting Luganville city to the airport.
